EXPERIMENTAL CONCRETE PAVEMENTS IN ALBERTA

A DISSERTATION

DEPARTMENT OF CIVIL ENGINEERING

COLIN J. KARASEK, B.Sc.

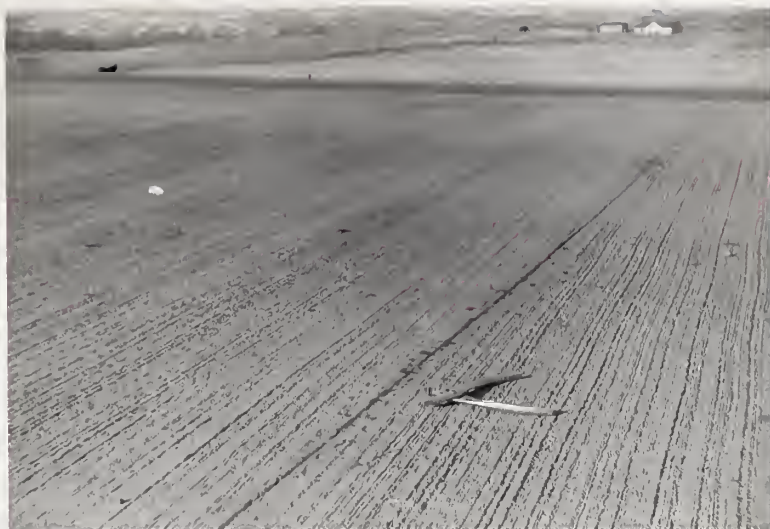
*SURFACE APPEARANCE FROM  
MECHANICAL BROOM*

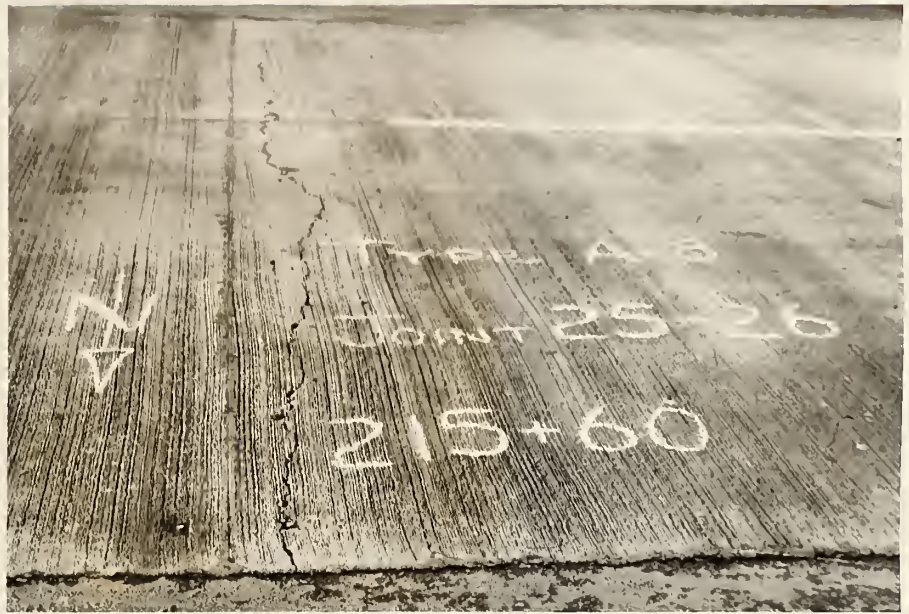
FIG. 1 UNCONTROLLED CRACK TYPE 3 AGE-3Mo.

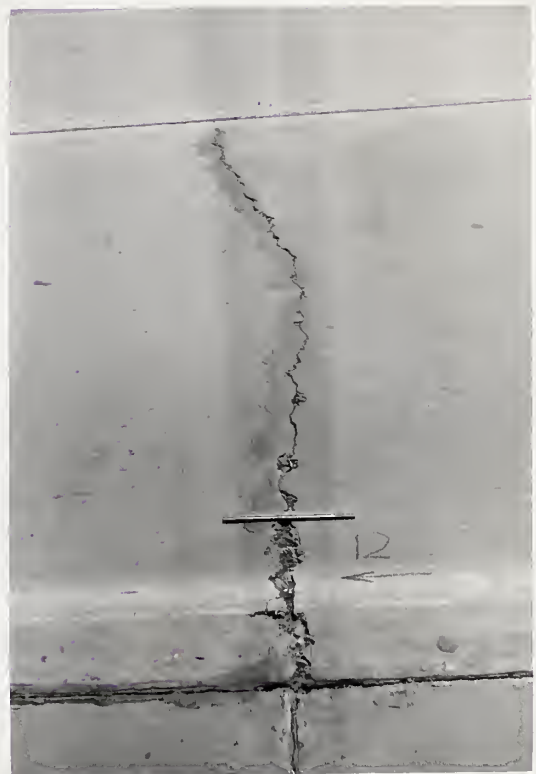
FIG 2. SYMPATHETIC  
CRACK TYPE 6  
AGE 3 YEARS

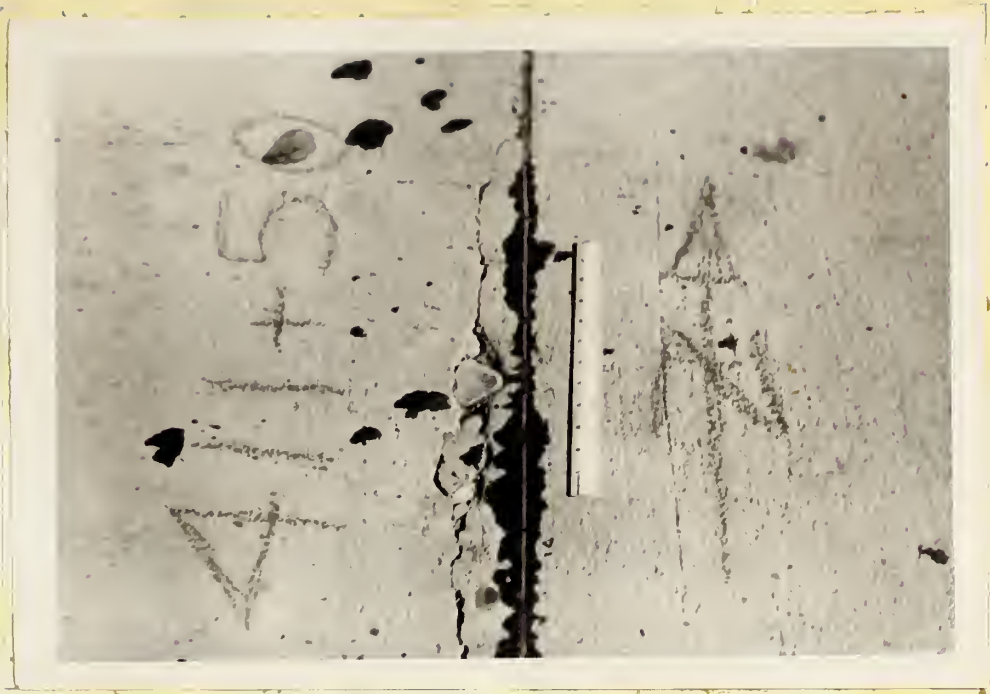
FIG.1. UNCONTROLLED CRACK DURING SAWING OF  
TRANSVERSE JOINT - MORTAR FLAKING FROM AGGREGATE  
AGE: 1 YEAR

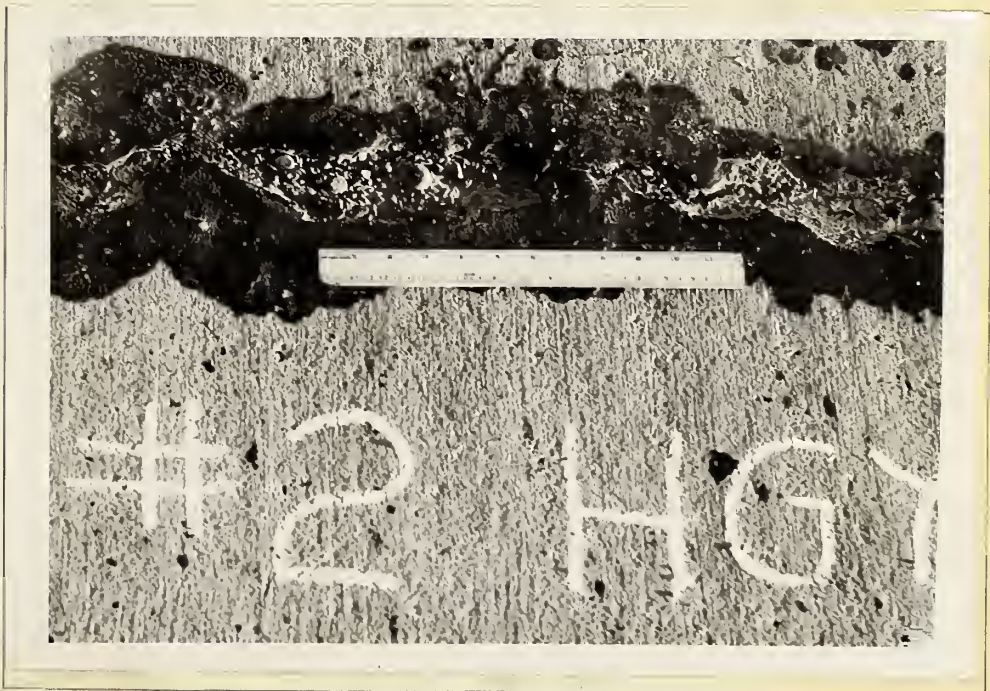
FIG 2. UNCONTROLLED CRACK IN UNREINFORCED SLAB #2 HGHY  
AGE: 4 YEARS.

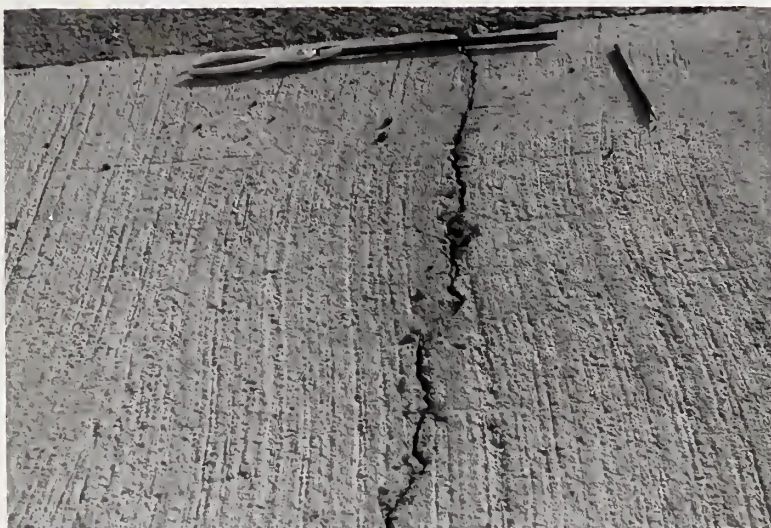
FAULTING AT UNCONTROLLED CRACK  
STATION 402+80 TYPE "C"  
AGE 6 MONTHS (MAR. 1959)

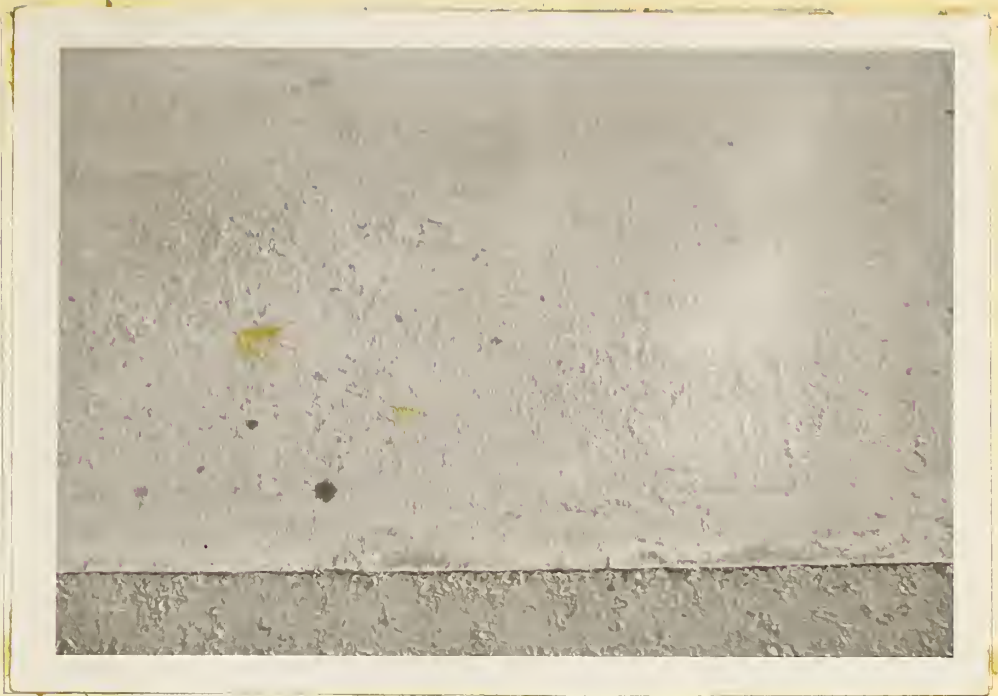
FIG 1. PITTING OF SURFACE  
AGE: 10 MONTHS

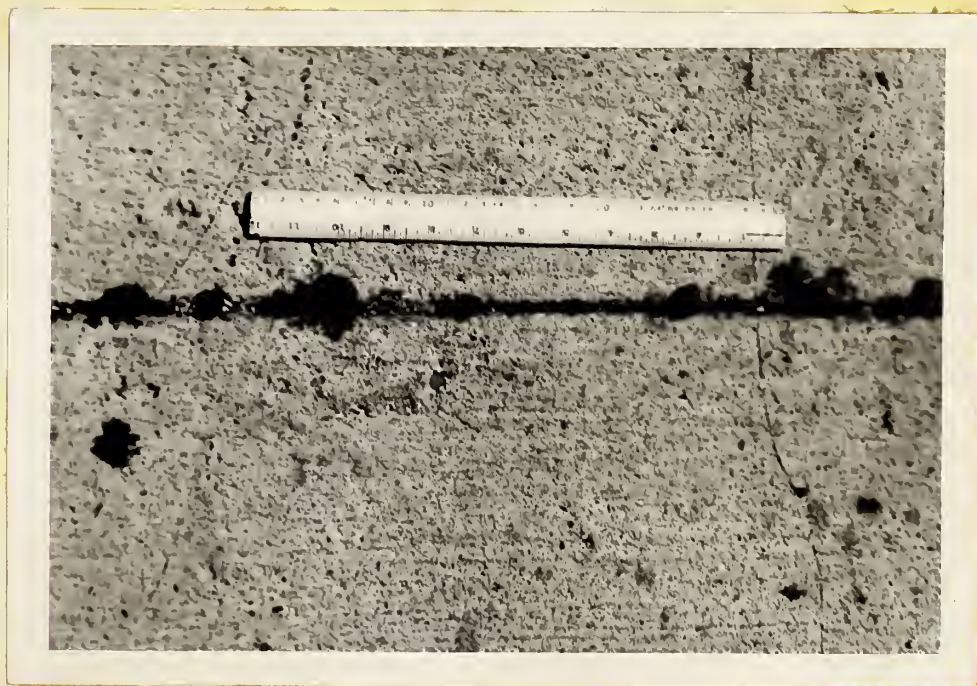
FIG. 2 TRANSVERSE CONTRACTION JOINT IN GOOD CONDITION  
1967 YEAR

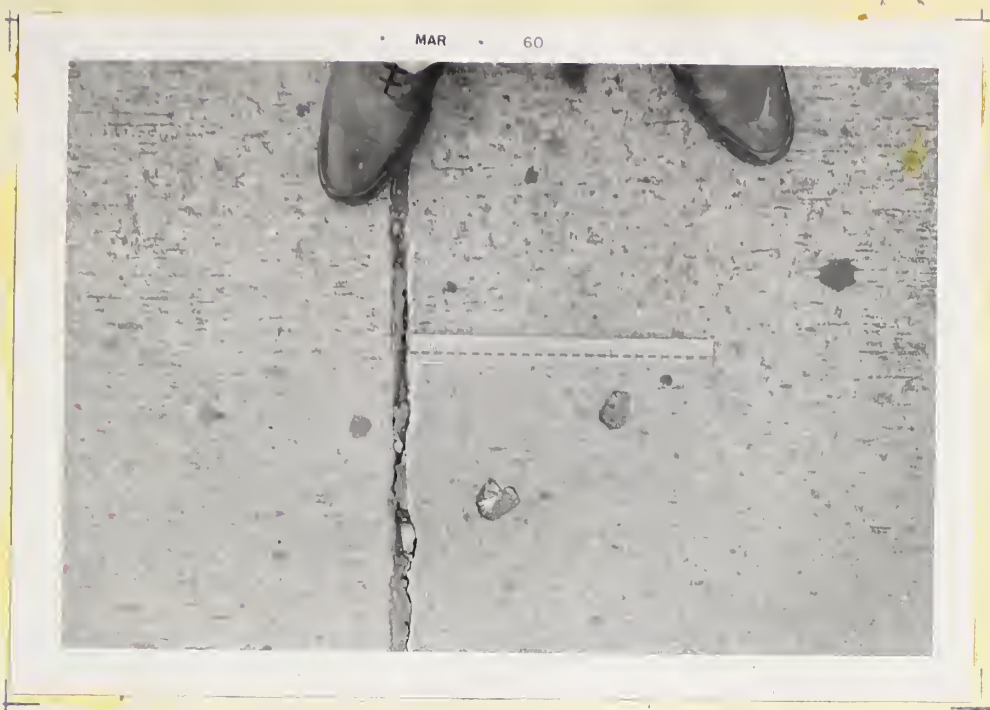
FIG.1 TRANSVERSE JOINT AGE-2½ YRS.  
NOVEMBER 1957

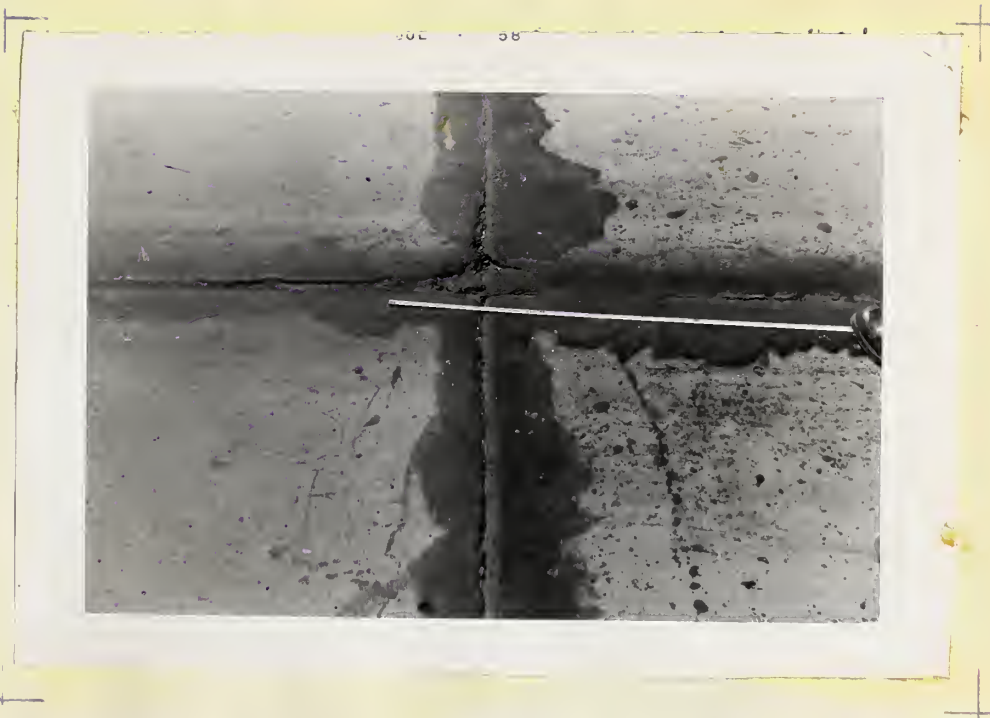
FIG.2. TRANSVERSE AND LONGITUDINAL JOINT AGE-3 YRS.  
JULY 1958

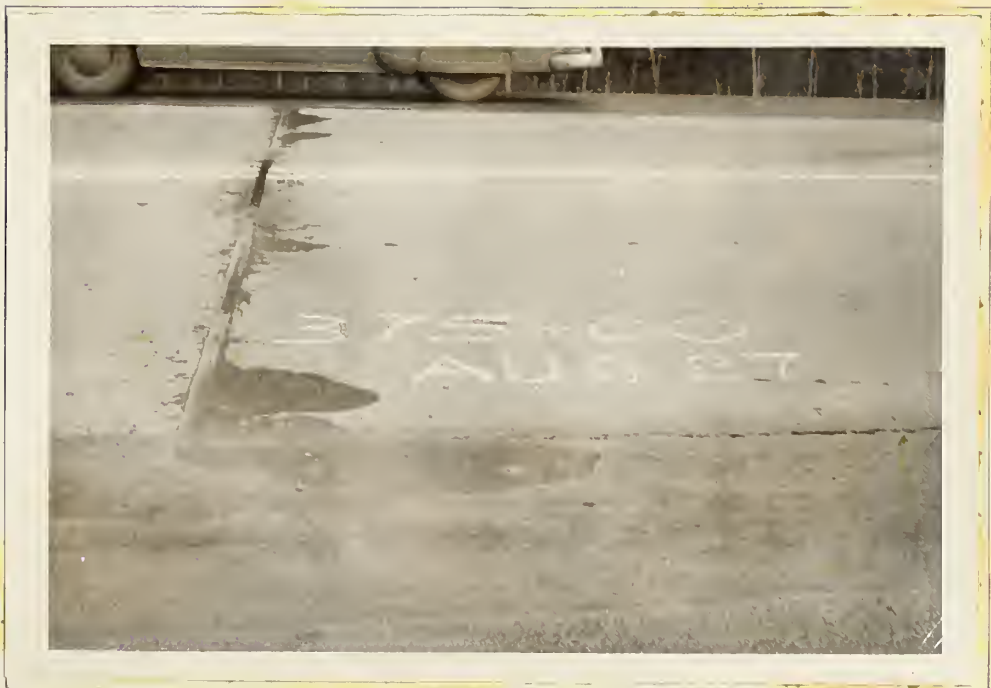
FIG. 2. FLOW OF JOINT SEALER FROM EXPANSION JOINT ON 5% GRADE (LOCATION SHOWN ON PLATE 6-A, TYPE C)

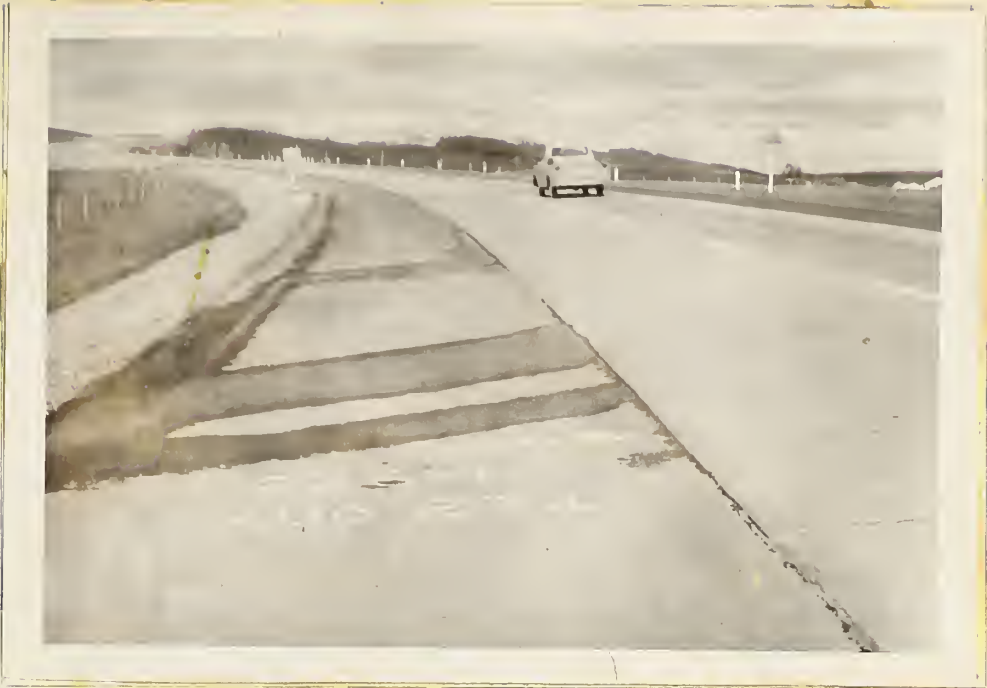
FIG 1 WATER OOZING FROM SHOULDER JOINT  
TYPE A-7 AGE 3½ MONTHS.

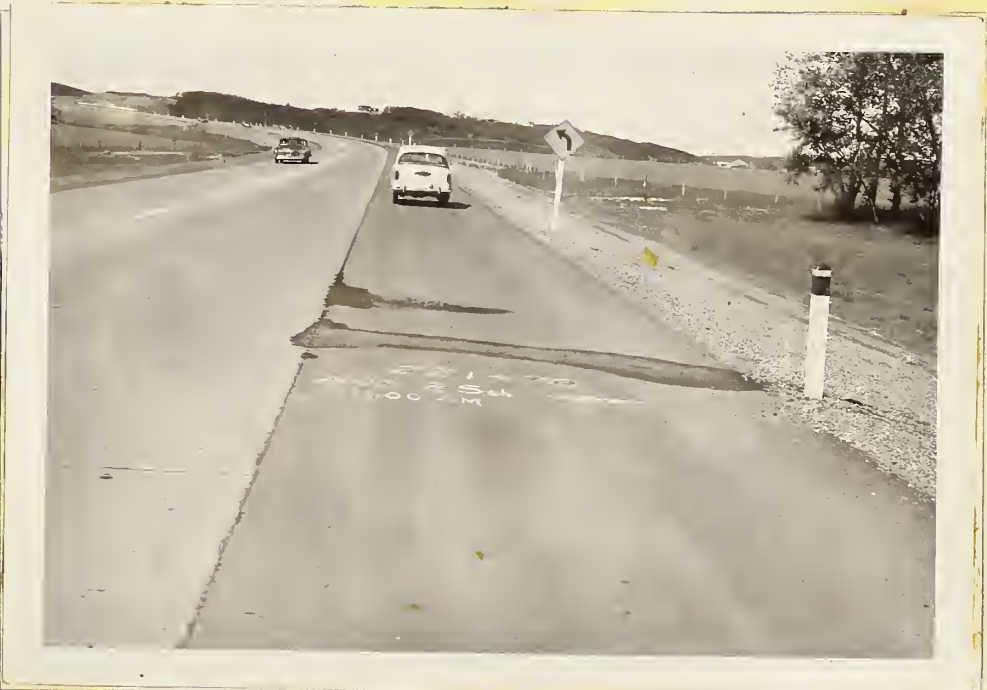
FIG 2. WATER OOZING FROM SHOULDER JOINT  
TYPE A-8 AGE: 3½ MONTHS

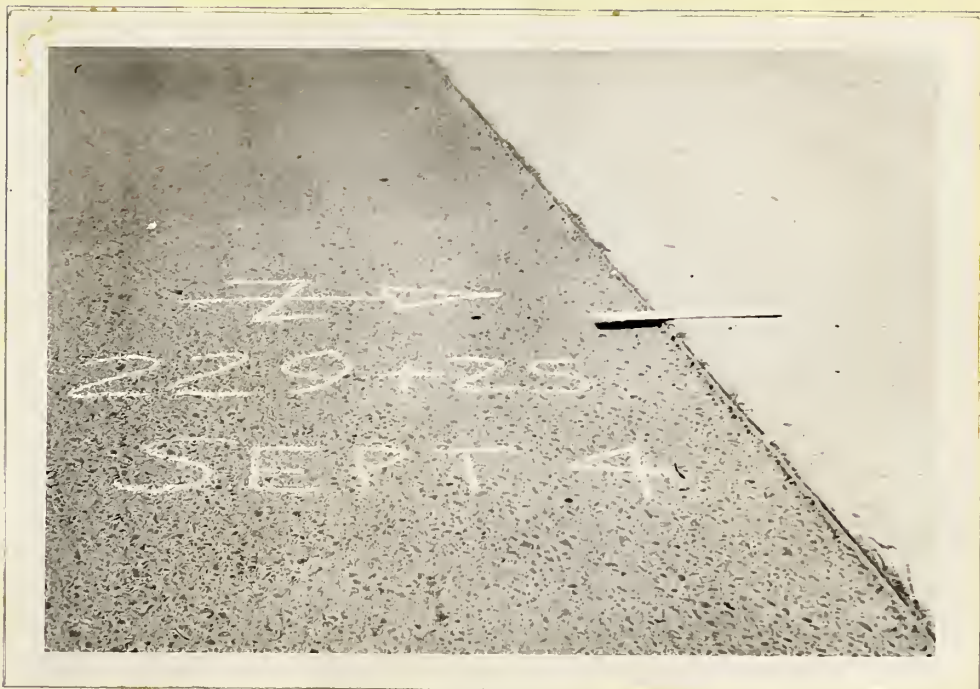
FIG. 2 SETTLEMENT OF THE SHOULDER  
TYPE A-7 AGE: 3 MONTHS

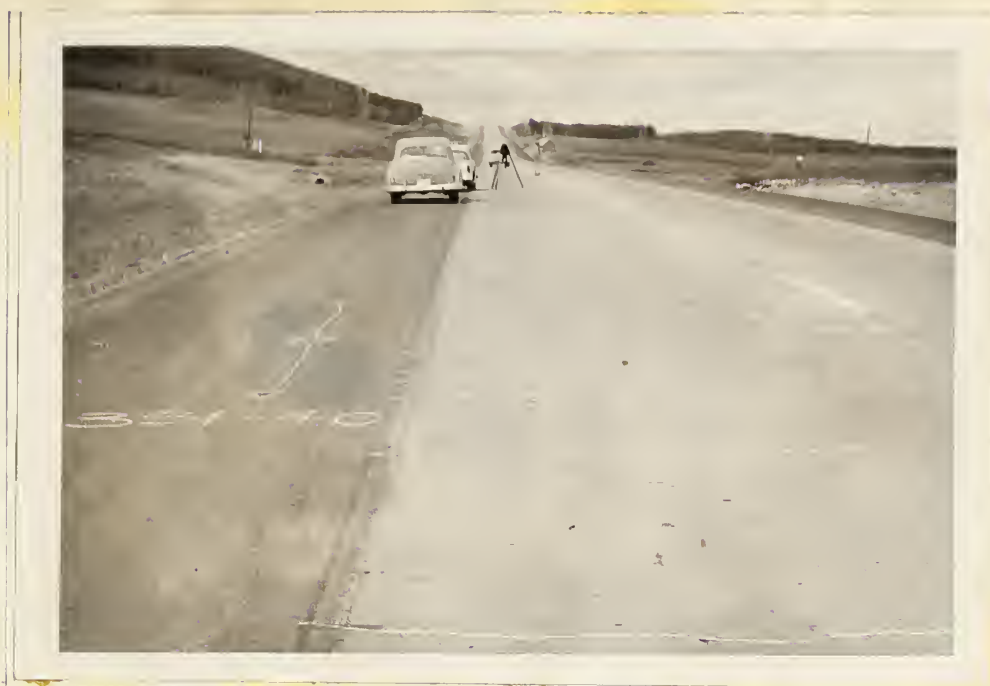
FIG 1

THE PHOTOGRAPH ILLUSTRATES IRREGULARITY OF CRACK SPACING IN THE 15' LENGTH OF PAVEMENT DESIGNATED BY THE ARROW, THERE ARE SEVEN SEGMENTS I.E CRACK SPACING IS 2.1'
